DEFENSE ATOMIC SUPPORT AGENCY WASHING
BIKINI SCIENTIFIC RESURVEY. VOLUME II
DEC 47

Bikini Scientific Resurvey, Annex I

SARATOGA: GENERAL DESCRIPTION OF DAMAGE

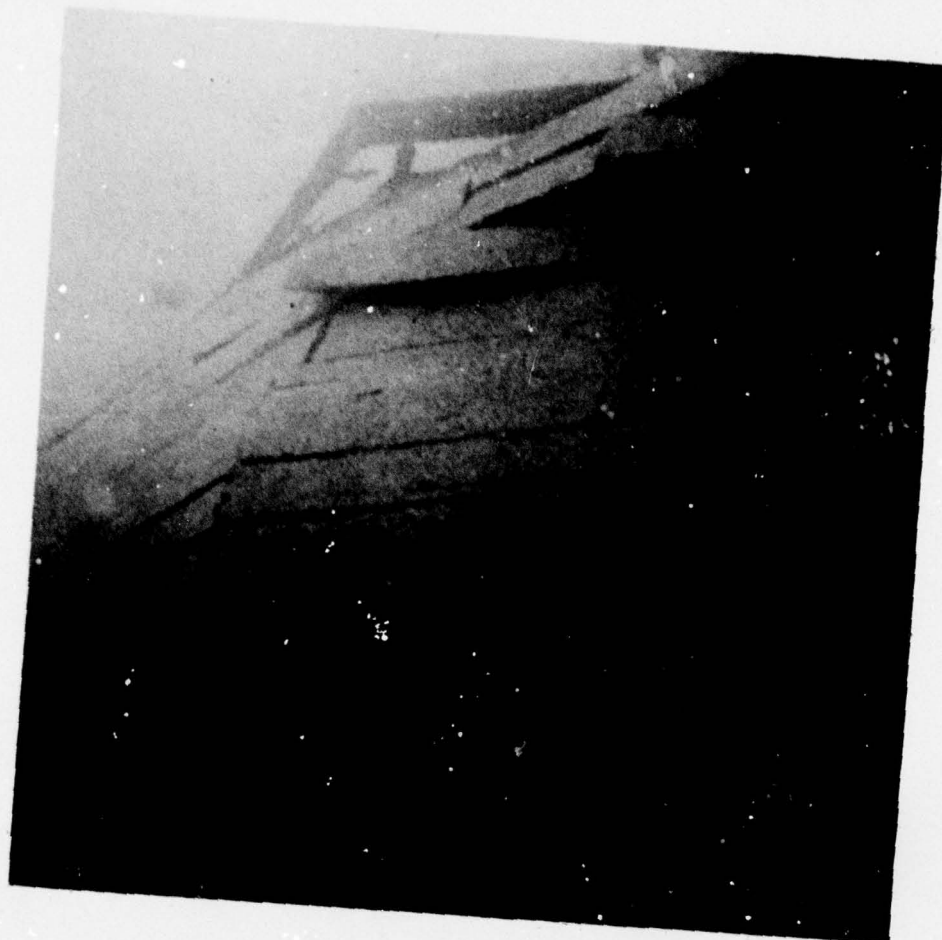
Figure 7. SARATOGA. Damaged flight deck, port side, about frame No. 157. ABCR Photo No. 6030-14.

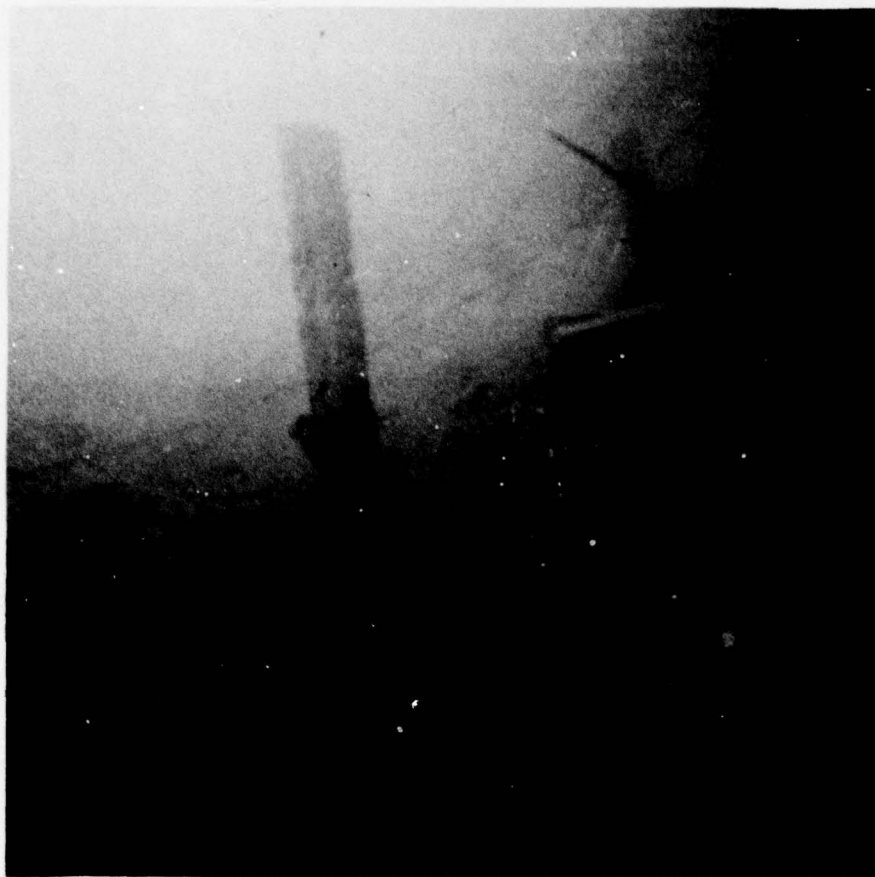
Figure 8. SARATOGA. Damaged deck about frame No. 162 near centerline. ABCR Photo No. 6030-15.

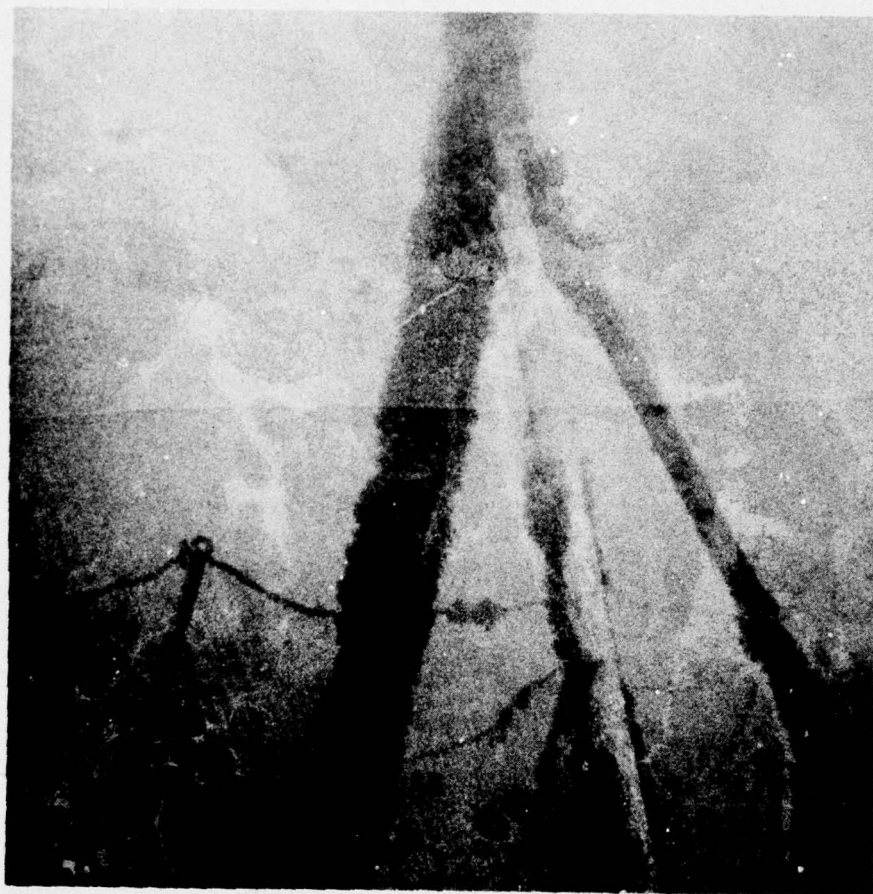
Jackstaff and forward lifeline damage. ABCR Photo No. 6002-8.

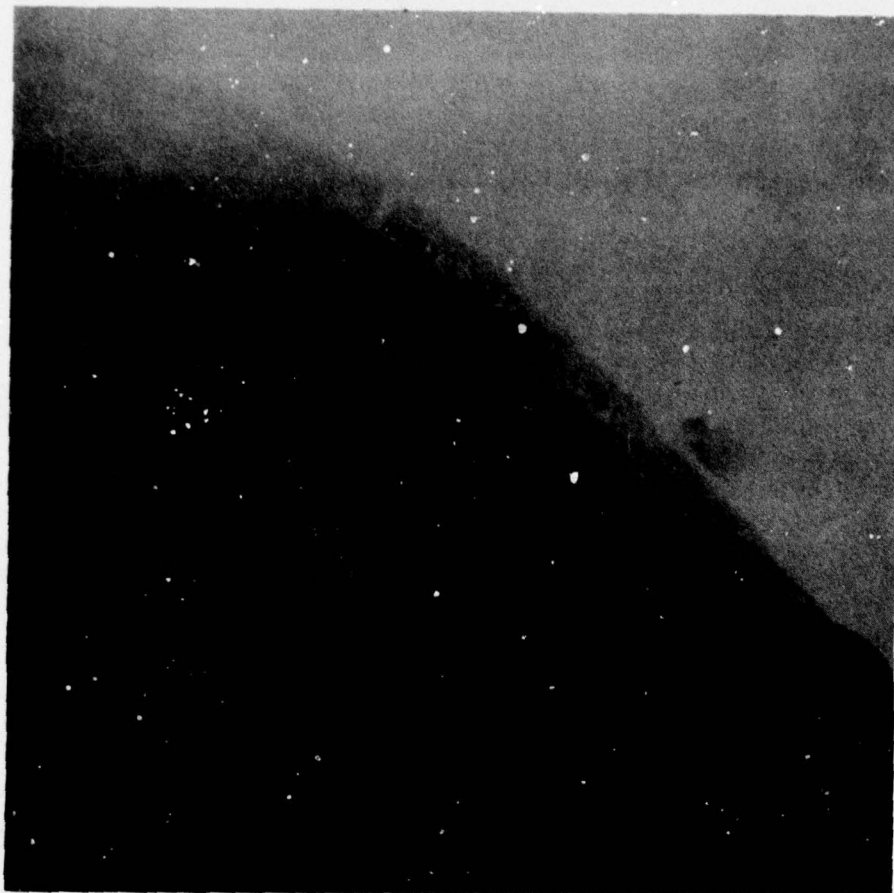
View of damage to stack near top of stack. ABCR Photo No. 6004-2.

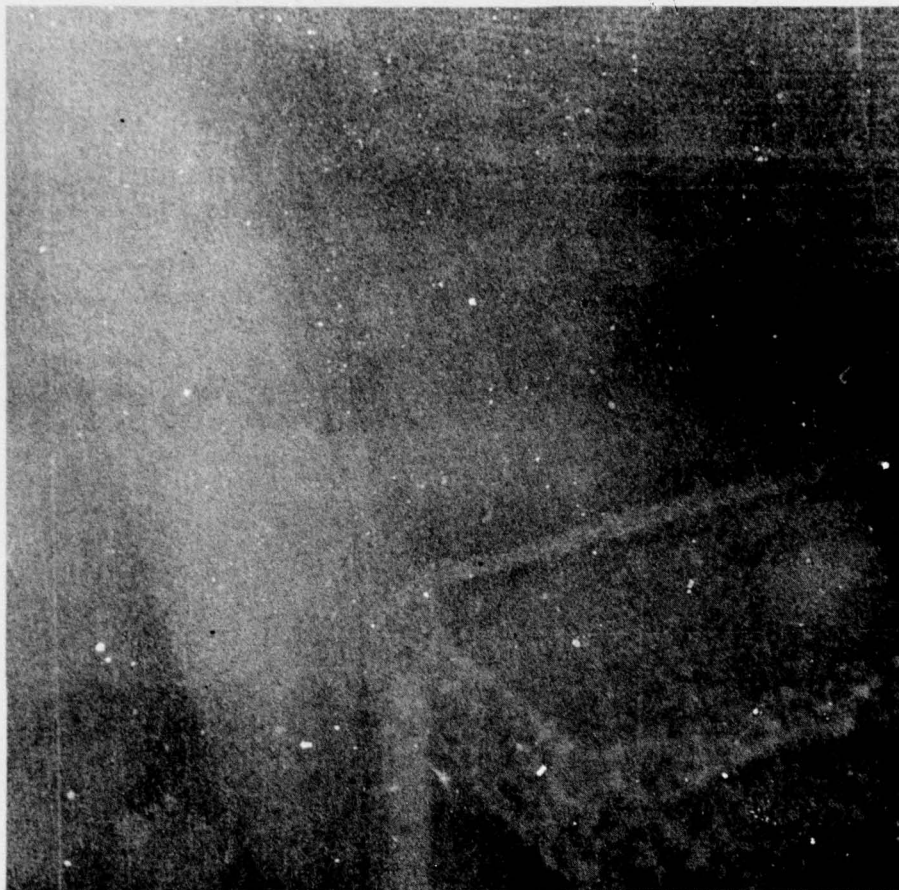
Unidentified damage near stack, presumably near forward edge of uptakes. ABCR Photo No. 6004-9.

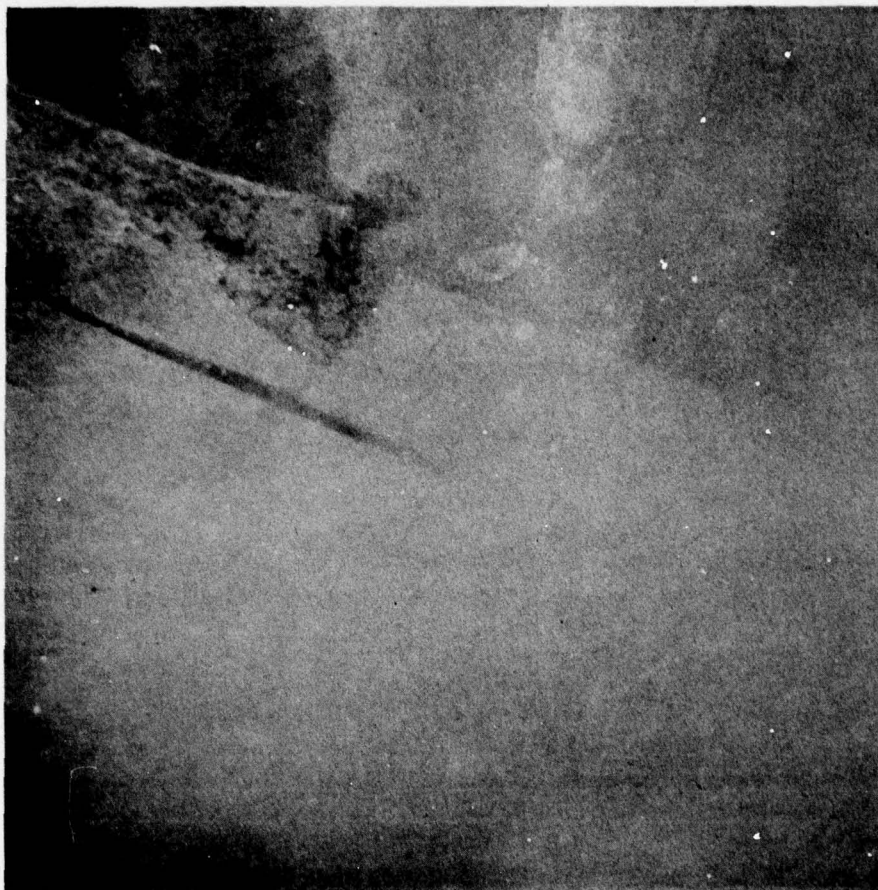
Damaged wood decking in way of broken stanchion, starboard side, between 5" 38 cal. mount #5 and forward deck house, about frame 59. ABCR Photo No. 6005-8.

Damaged wood decking in way of broken stanchion, starboard side, between 5" 38 cal. mount #5 and forward deck house, about frame 59. ABCR Photo No. 6005-9.

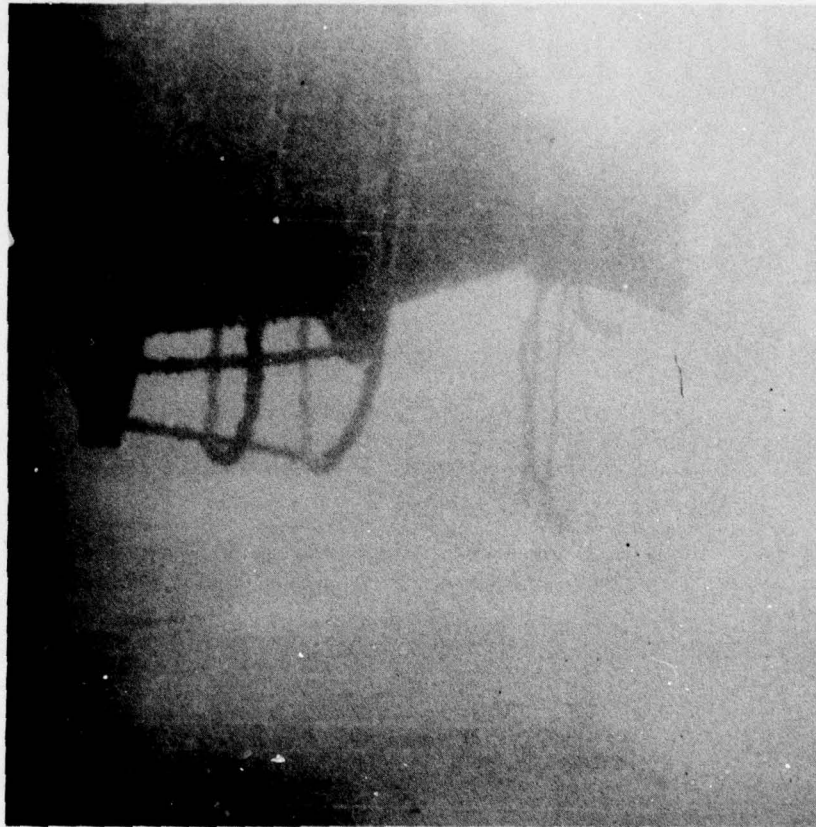
Radar Antenna found on stack top lying across flight deck,
looking aft. ABCR Photo No. 6005-17.

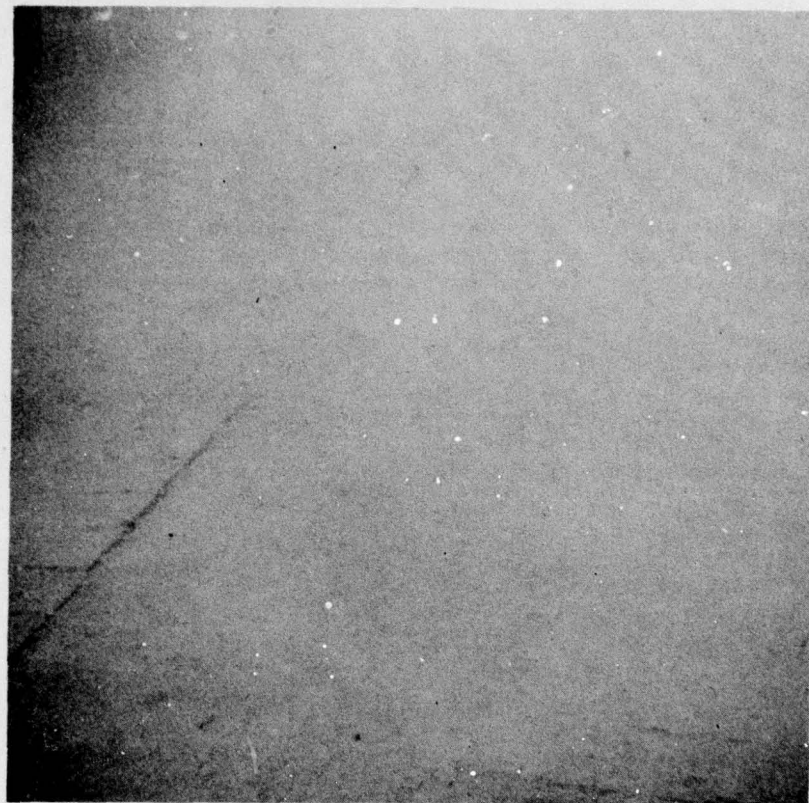
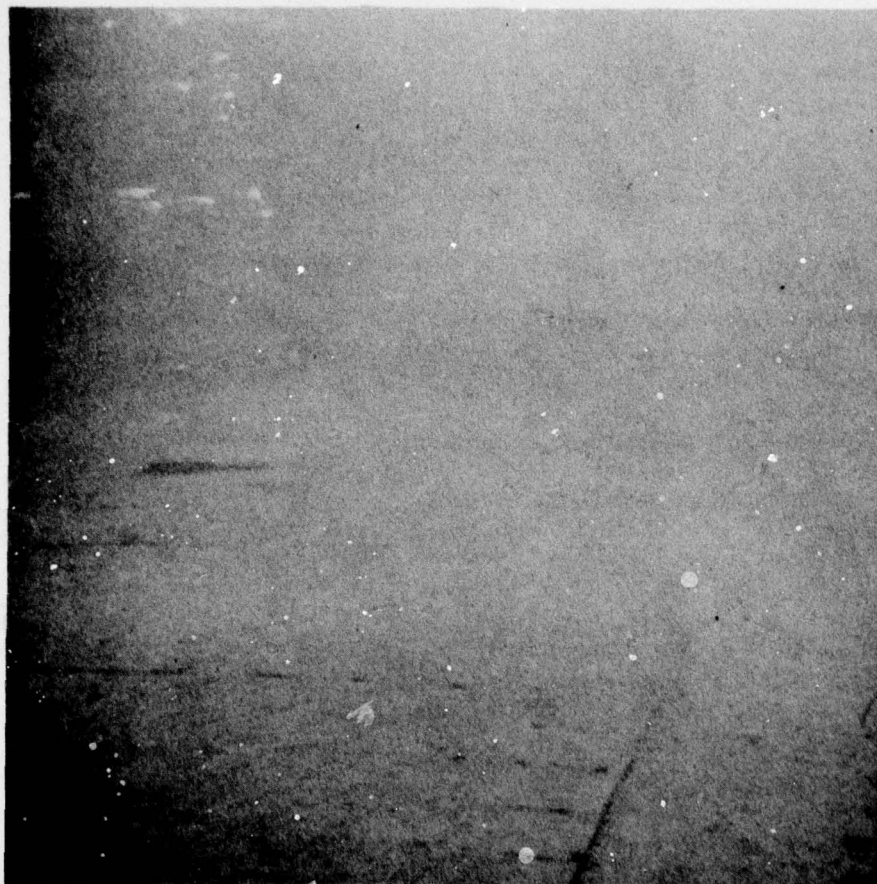
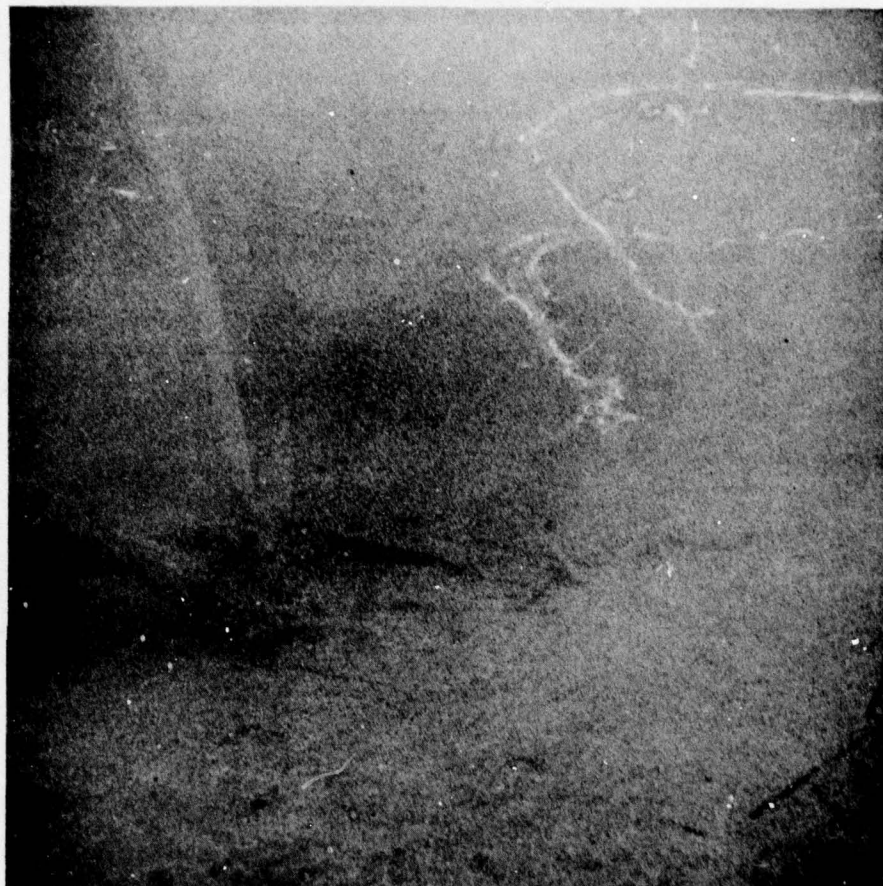
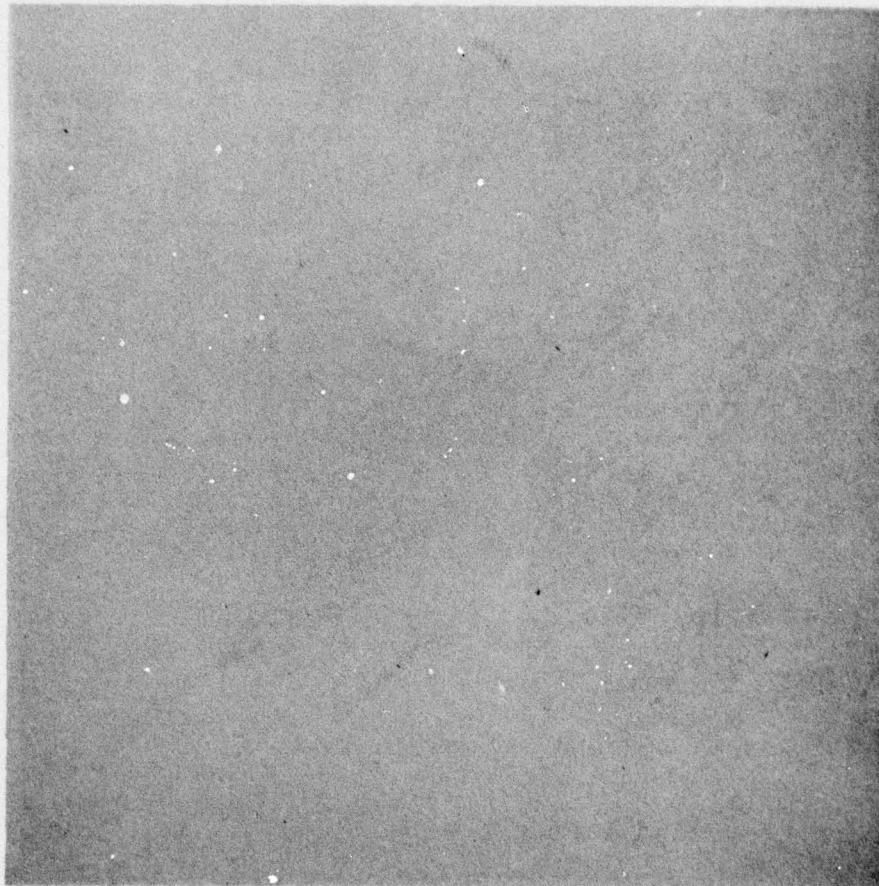
Damaged wood decking in way of top forward end of stack. ABCR
Photo No. 6007-6.

Damaged wood decking in way of top forward end of stack. ABCR
Photo No. 6007-7.

Damaged wood decking in way of top forward end of stack. ABCR
Photo No. 6007-10.

Damaged wood decking in way of top forward end of stack. ABCR
Photo No. 6007-11.

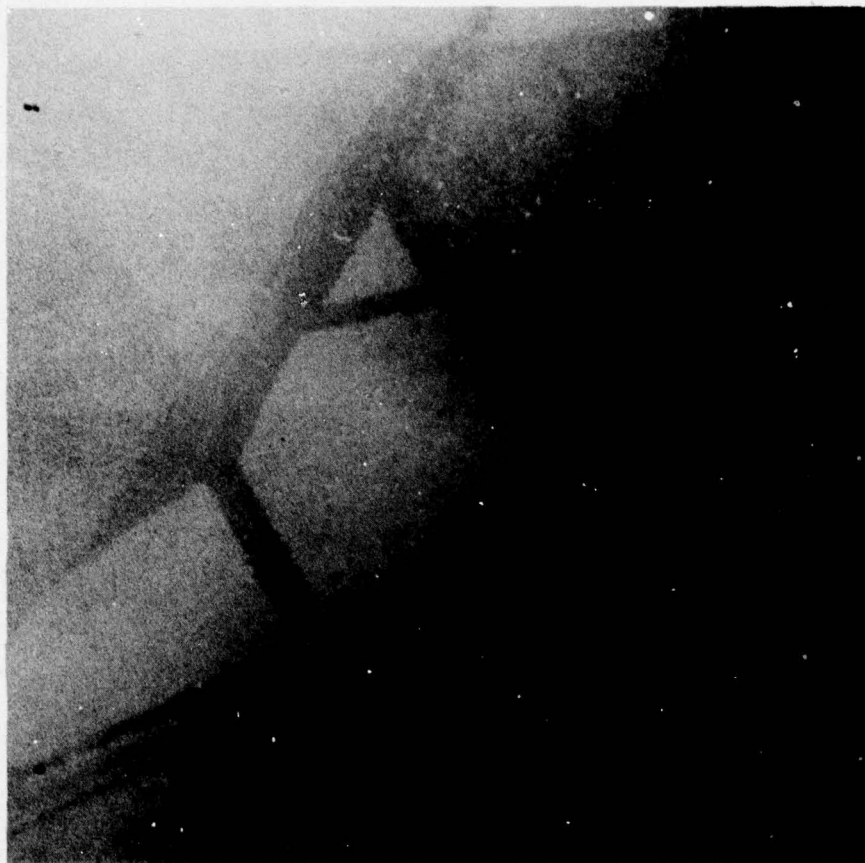
Port side, main deck, about frame 192 near crack. ABCR Photo
No. 6014-3.

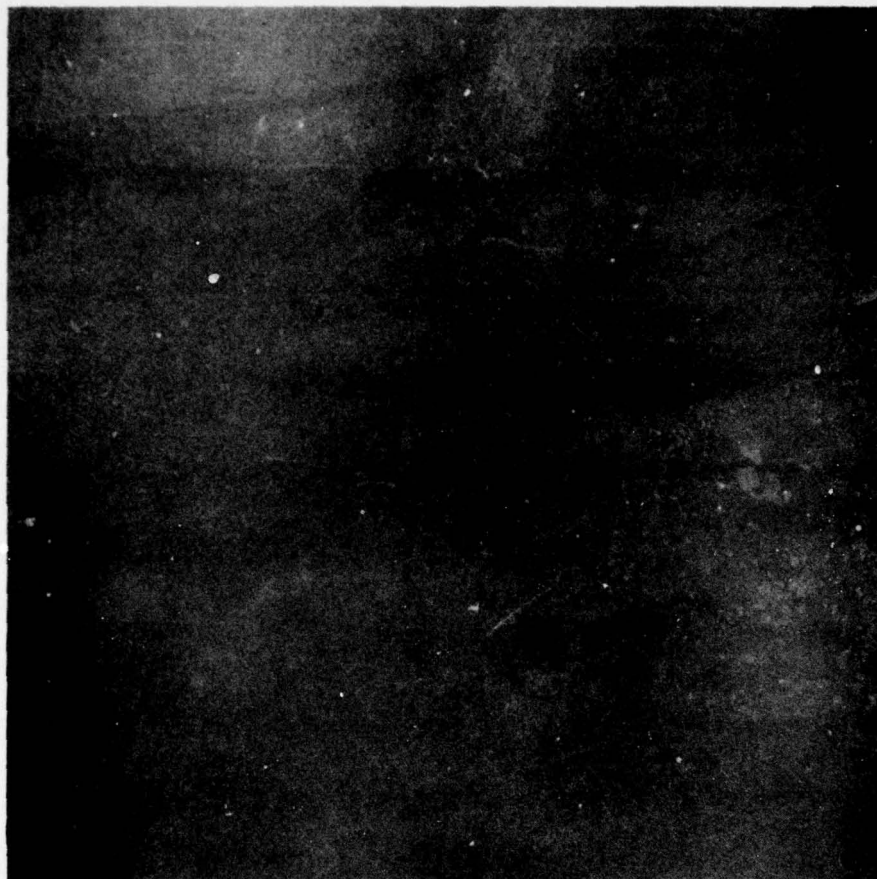
Damaged flight deck just aft of last 40mm mount looking from
aft forward. Note bump over transverse girder 190. ABCR
Photo No. 6023-3.

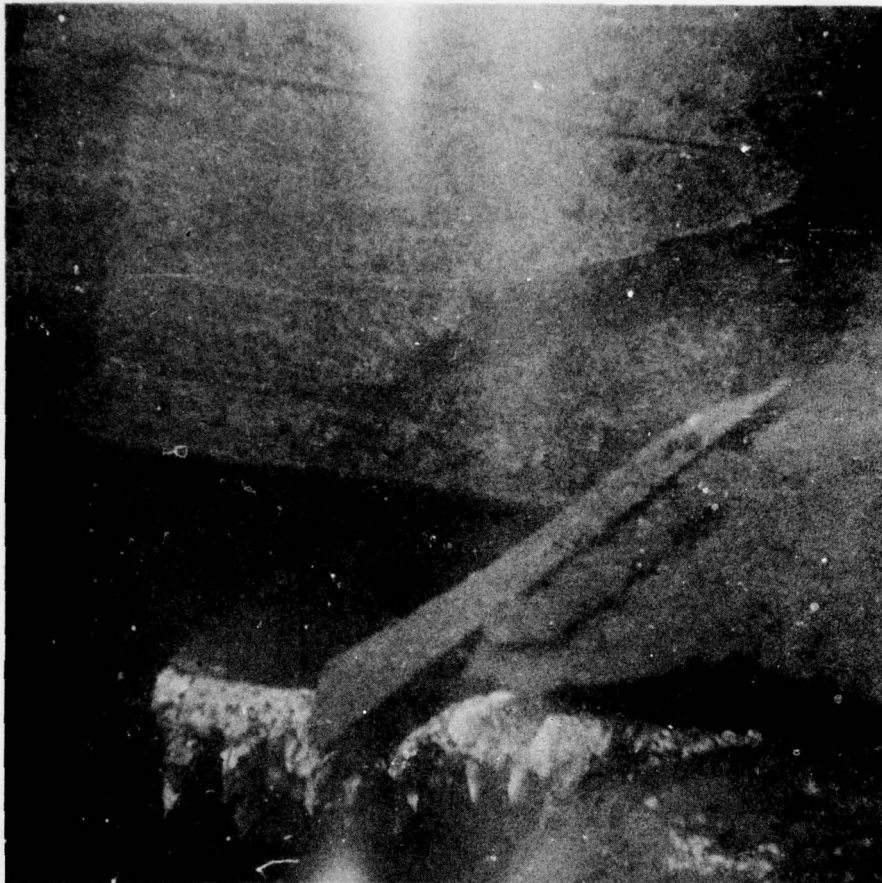
Stack where it is broken from base showing uptake #3 or 4.
ABCR 6026-1.

Stack where it is broken from base showing uptake #3 or 4.
ABCR Photo No. 6026-2.

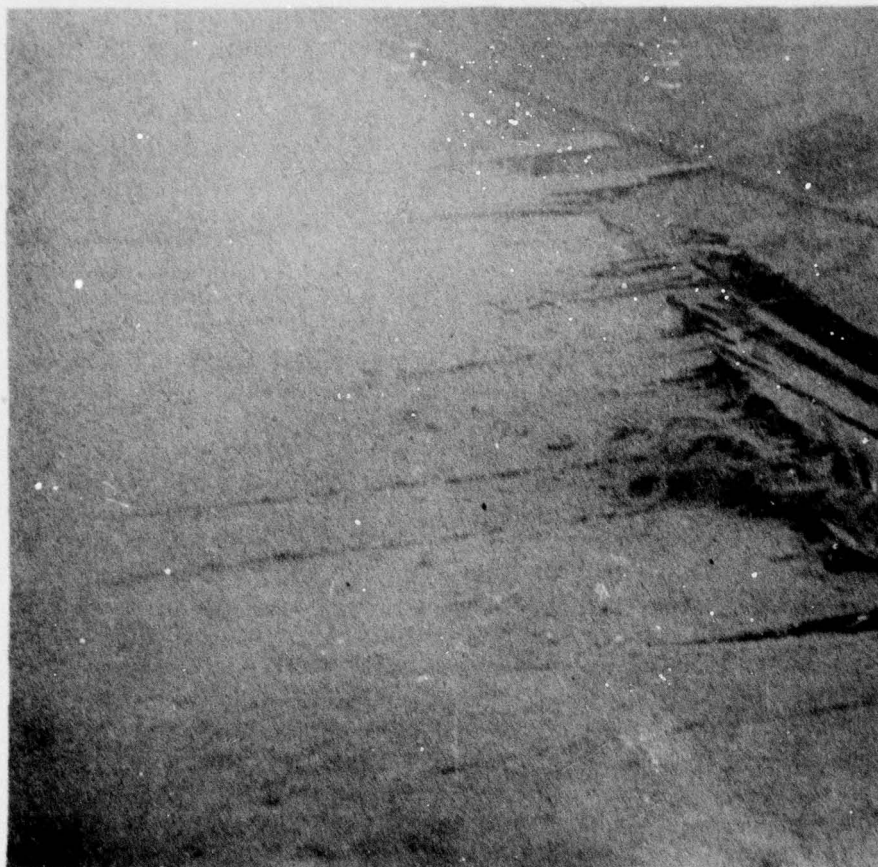
#1 of a series of photographs of damaged flight deck on port side looking forward, about frame 182. ABCR Photo No. 6027-3.

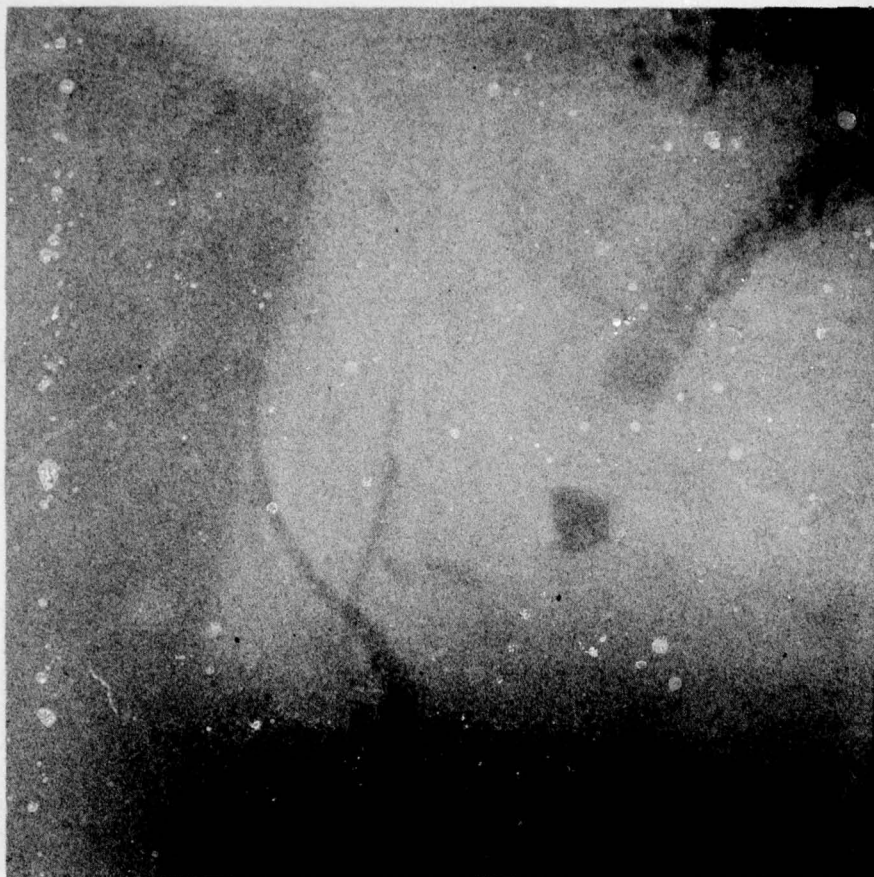
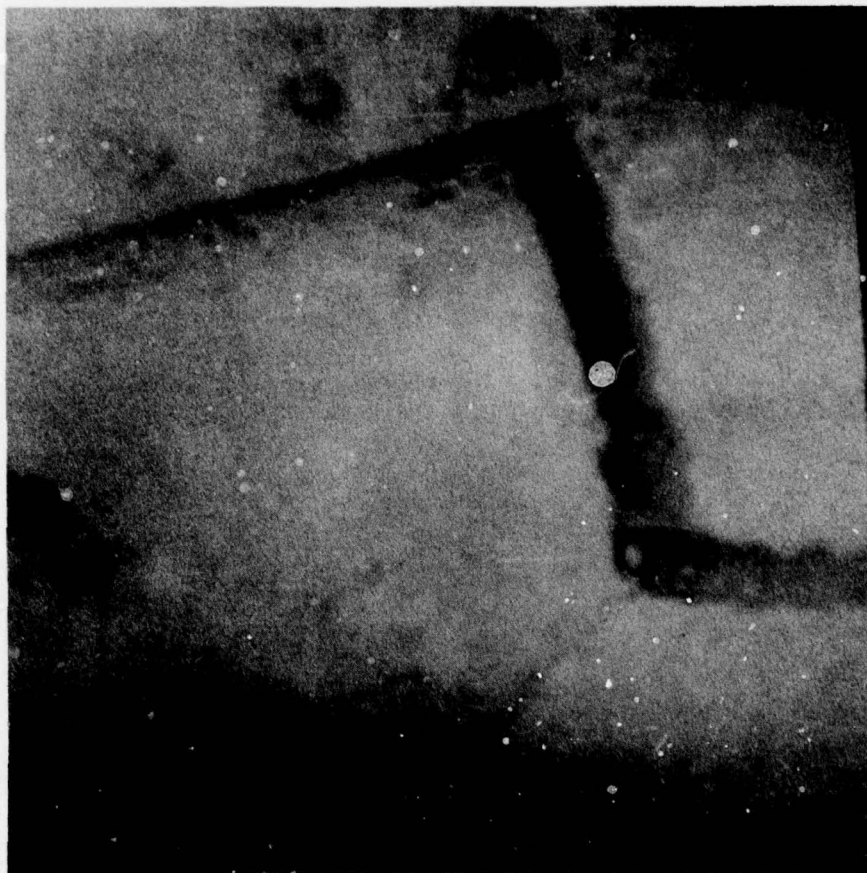
The rudder and after end of the ship were reported to be in good condition with the exception of No. 1 and No. 3 shafts, stern tubes, and struts. No. 1 and No. 3 stern tubes are ruptured; No. 1 along the side with the crack tapering in two places into the hull, and No. 3 along the top. No. 1 strut is broken at the barrel, and about 6 in. from the hull, and the one propeller blade which is visible is also broken. No. 3 strut is broken at the hull and about 12 in. from the barrel. Both shafts appear to be well out of line and possibly bent or broken. The hull is ripped open several inches where the upper palm of No. 3 strut was secured.

#1 stern tube showing crack. ABCR Photo No. 6028-1.

#1 stern tube showing crack. ABCR Photo No. 6028-2.

#1 stern tube showing end of crack. ABCR Photo No. 6028-3.
END.

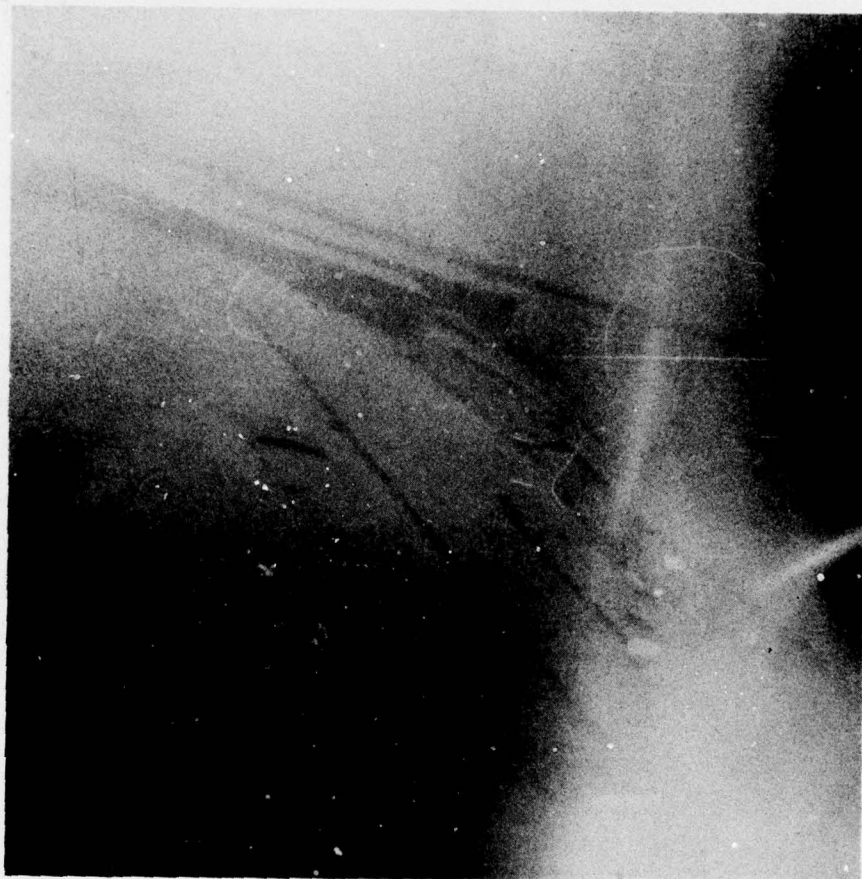
View of broken flight deck, port side looking forward, about
frame 136. ABCR Photo No. 6030-7.

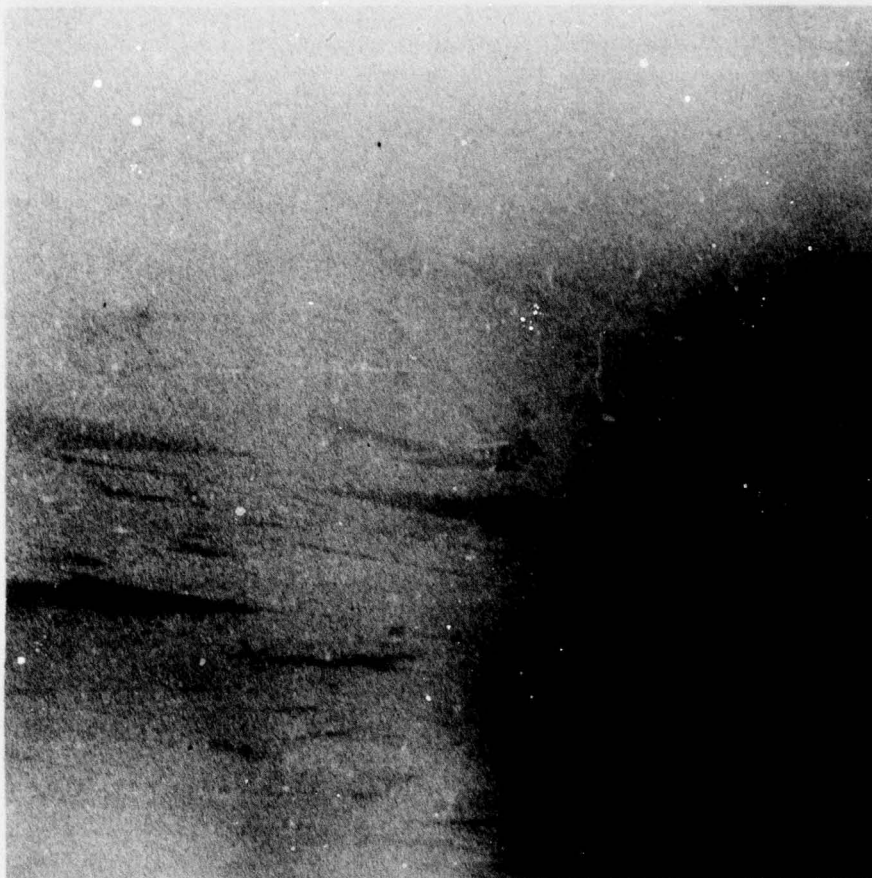
View of broken flight deck, port side looking forward, about
frame 140. ABCR Photo No. 6030-8.

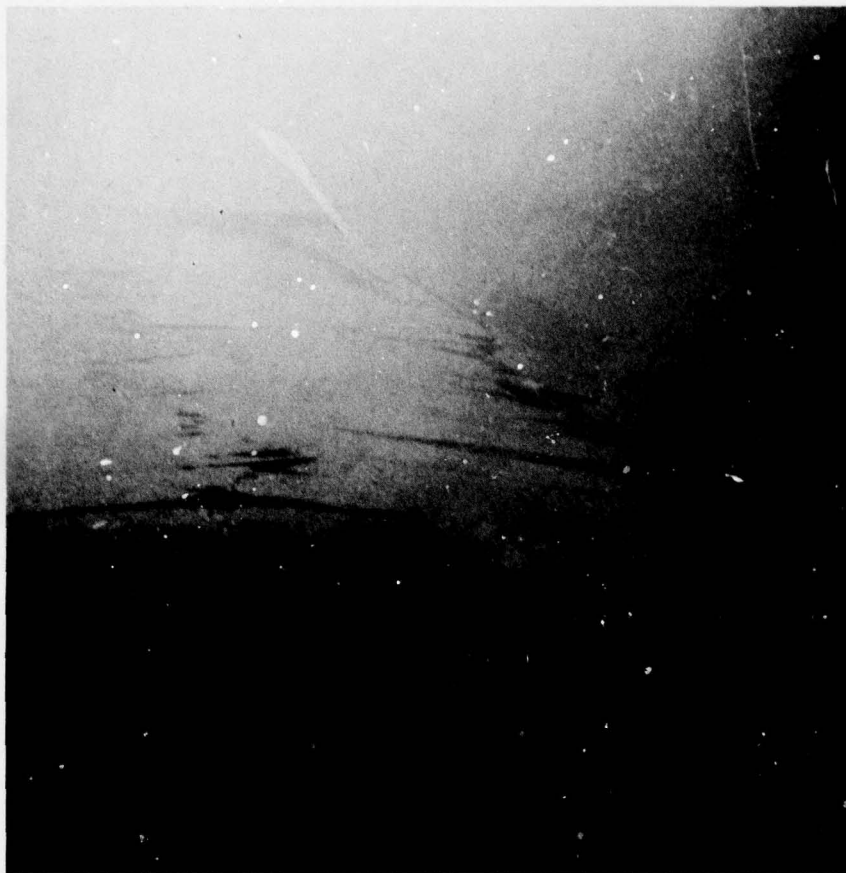
View of broken flight deck, port side looking forward, about frame 144. ABCR Photo No. 6030-9.

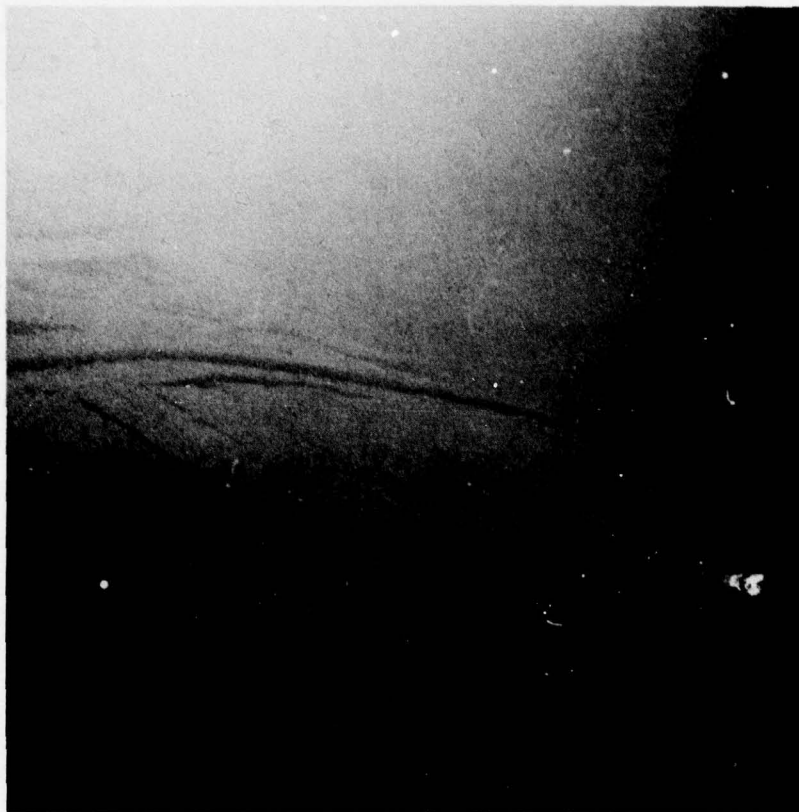
View of broken flight deck, port side looking diagonally forward, about frame 150. ABCR Photo No. 6030-11.

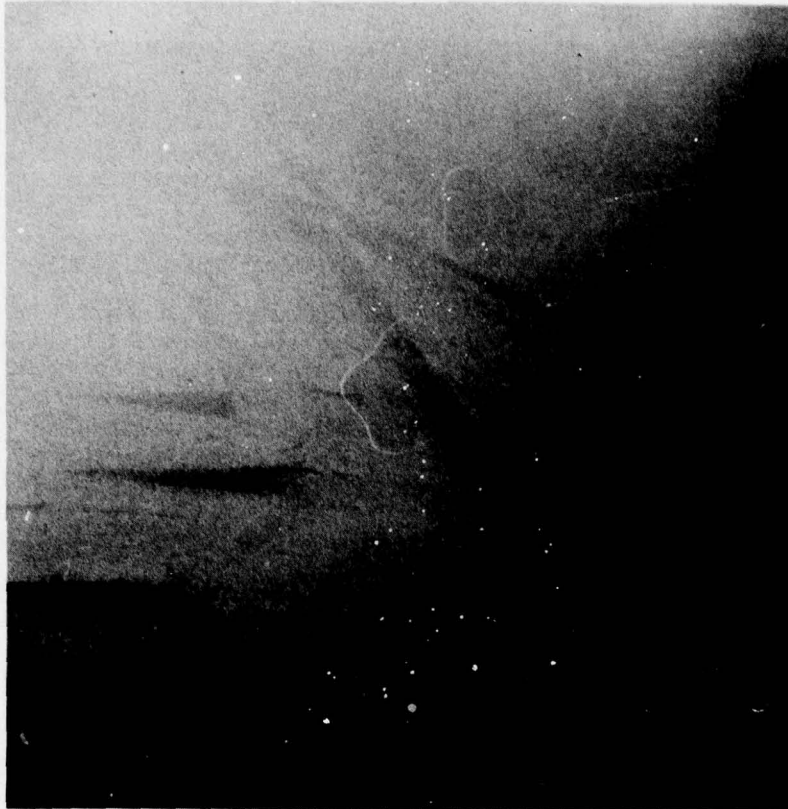
View of broken flight deck, port side looking forward, about
frame 128. ABCR Photo No. 6030-3.

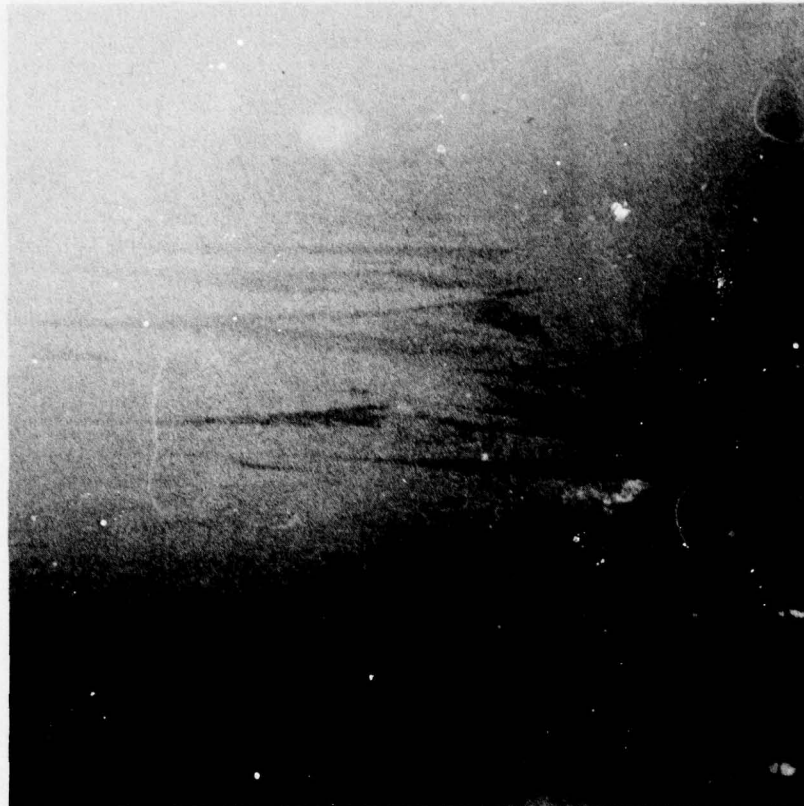
View of broken flight deck, port side looking forward, about
frame 132. ABCR Photo No. 6030-5.

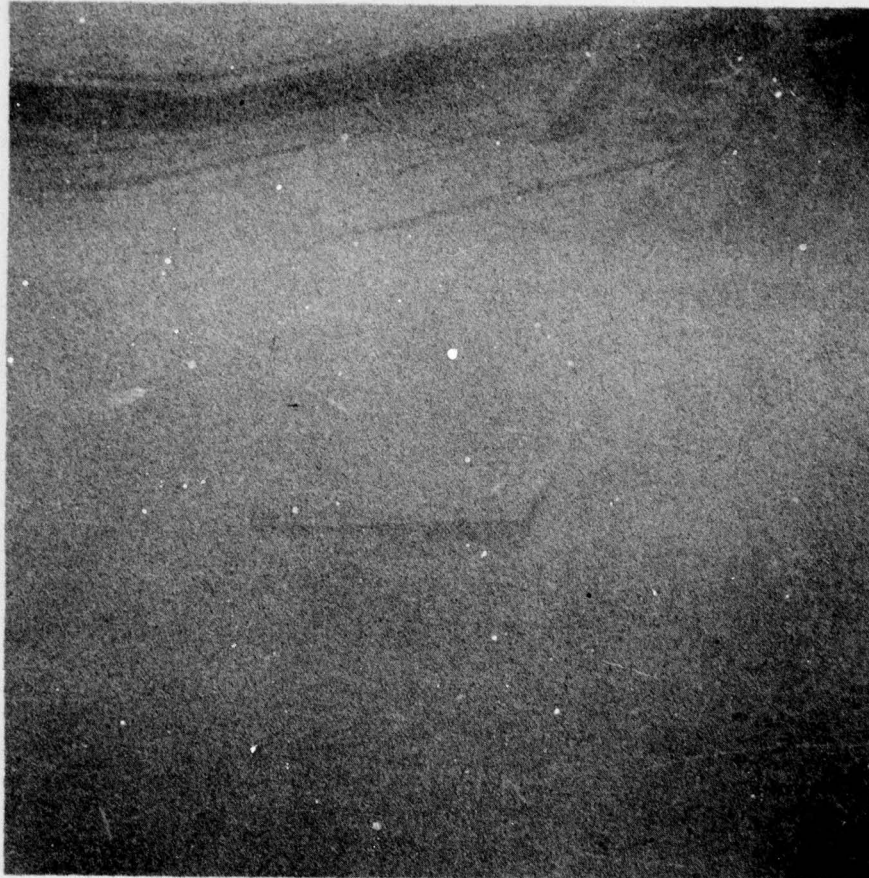
#2 of a series of photographs of damaged flight deck near centerline about frame 180. ABCR Photo No. 6027-5.

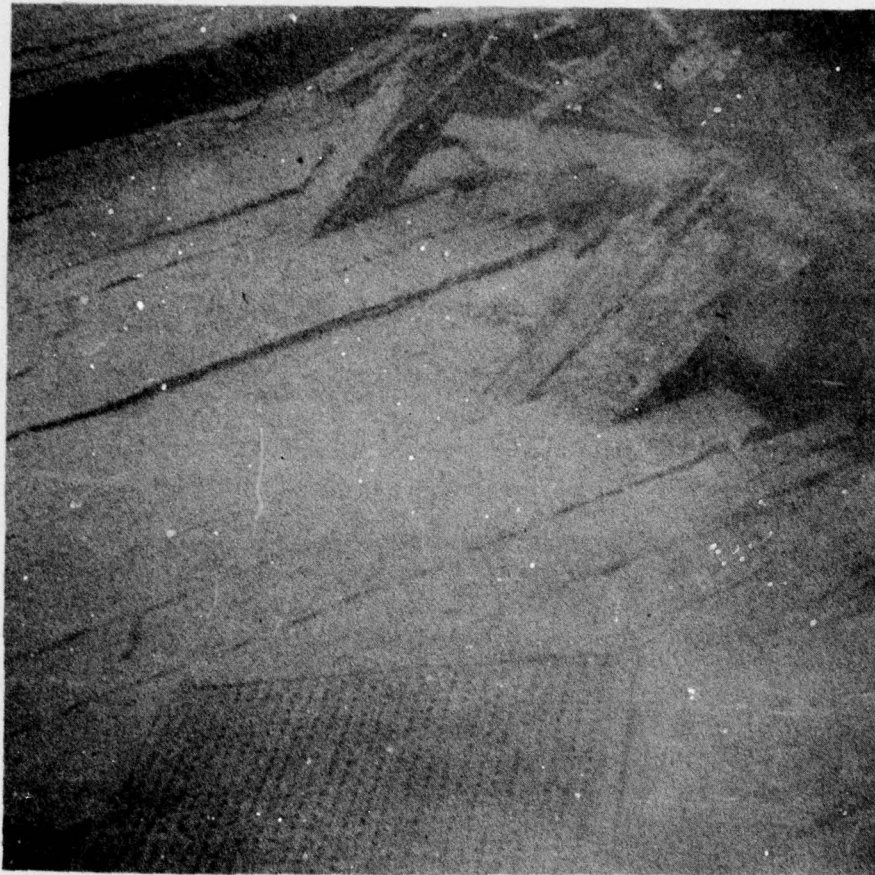
#3 of a series of photographs of damaged flight deck near centerline about frame 178. ABCR Photo No. 6027-6.

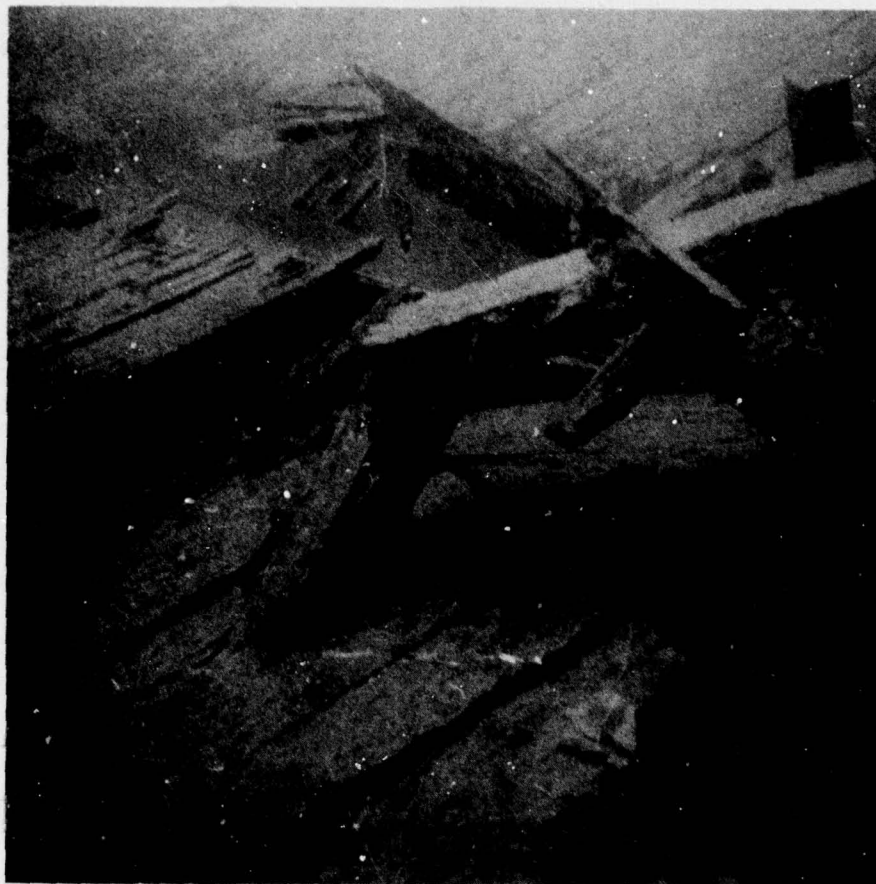
#4 of a series of photographs of damaged flight deck near centerline about frame 177. ABCR Photo No. 6027-7.

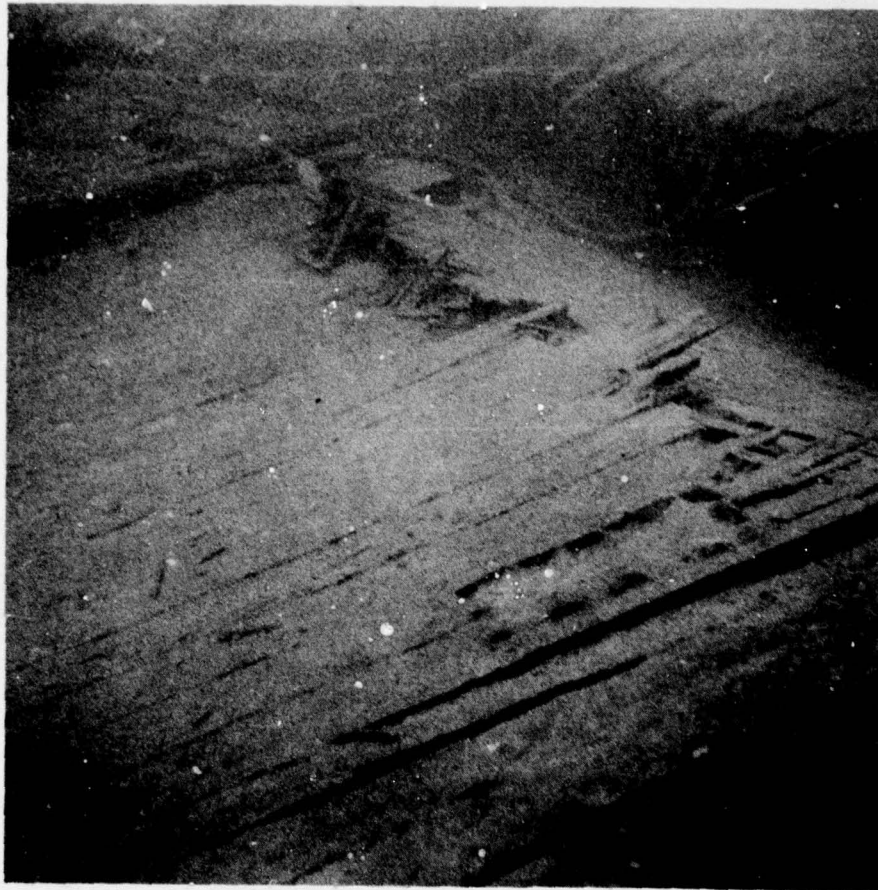
#5 of a series of photographs of damaged flight deck near centerline about frame 176. ABCR Photo No. 6027-S.

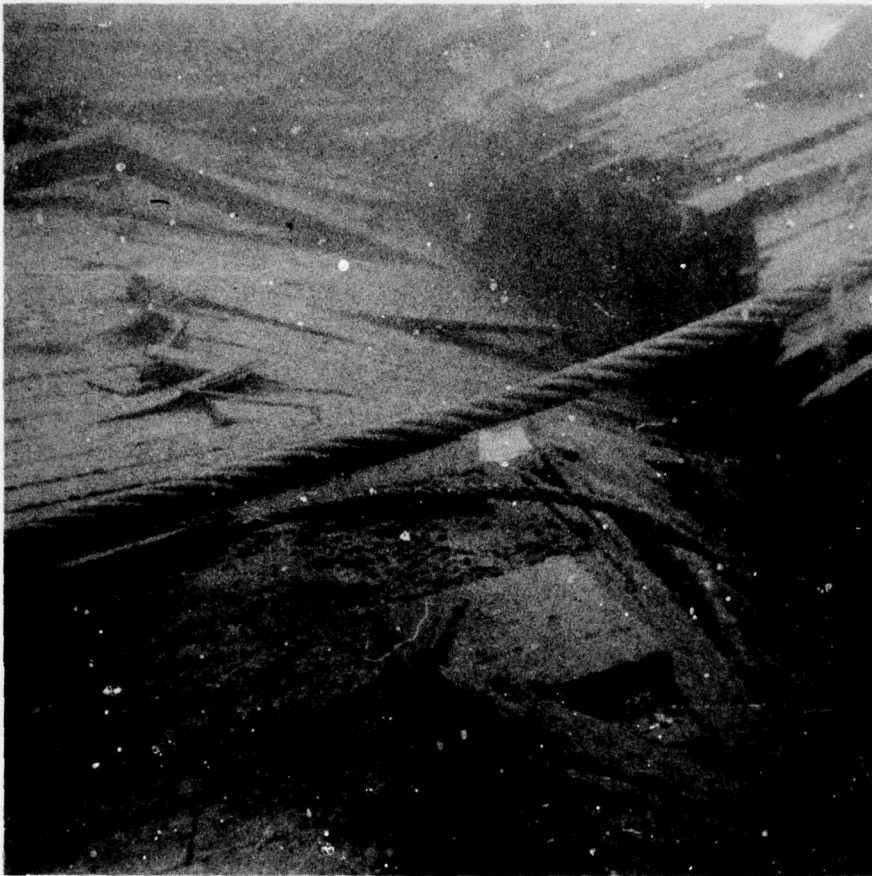
#6 of a series of photographs of damaged flight deck near centerline about frame 175. ABCR Photo No. 6027-9.

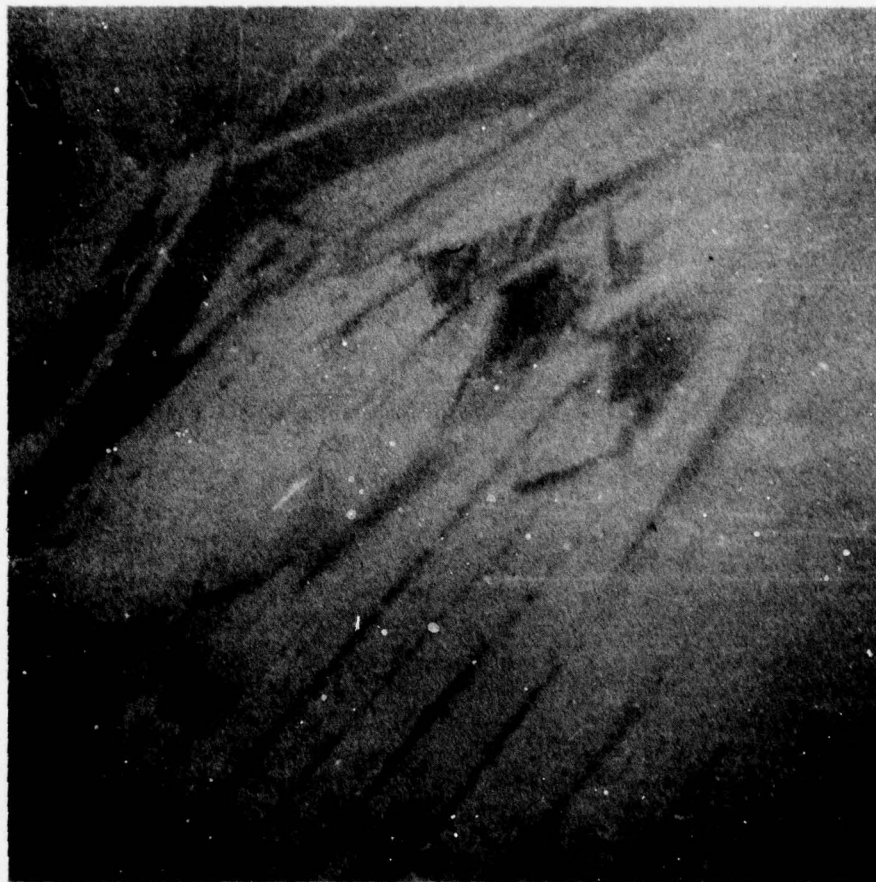
#7 of a series of photographs of damaged flight deck near centerline about frame 172 showing slope up to starboard. ABCR Photo No. 6027-10.
